TDR-EBS-MD-000018 REV 00

## **Engineered Barrier Systems Thermal-Hydraulic-Chemical Column Test Report**

Prepared for:  
U.S. Department of Energy  
Yucca Mountain Site Characterization Office  
P.O. Box 30307  
North Las Vegas, Nevada 89036-0307

Prepared by:  
Bechtel SAIC Company LLC  
1180 Town Center Drive  
Las Vegas, Nevada 89144

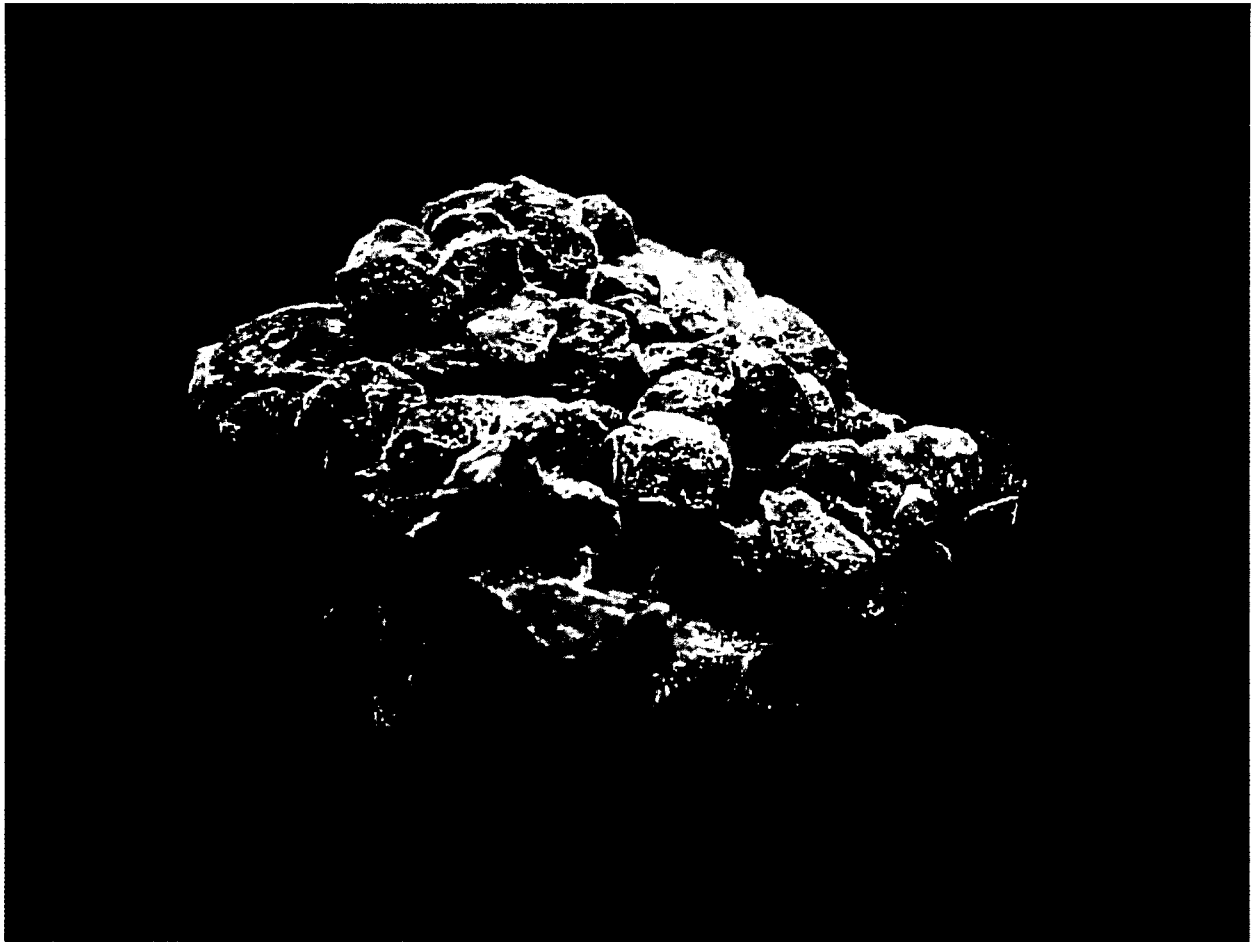
Photo II-4. Close-Up of Cemented Rock Mass From Lift 1.
